Government of Maharashtra
Water Resources Department

Annual Dam Health Status Report
2021-22
(Nagpur Region)

Superintending Engineer
Dam Safety Organisation
Nashik

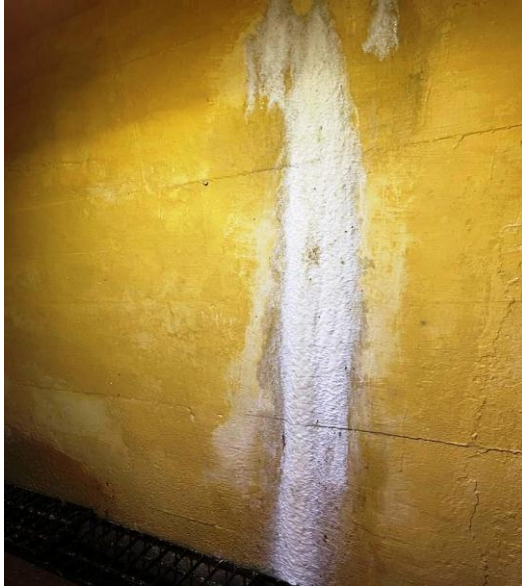
Snapshot-1

**Totaladoh Dam (Class-I, National Important dam)
Taluka – Ramtek Dist - Nagpur
Date of Inspection – 28-03-2022**

White leaching material is observed on upstream face of gallery at many places.

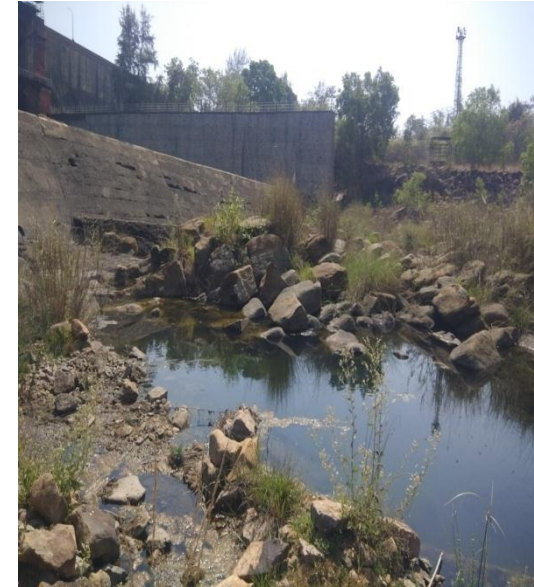
Snapshot -2

**Erai Dam (Private Dam) (Class-I)
Taluka & Dist – Chandrapur
Date of Inspection – 39/03/2022**
