Annual Dam Health Status Report
2021-22

Amravati Region

Superintending Engineer
Dam Safety Organisation
Nashik

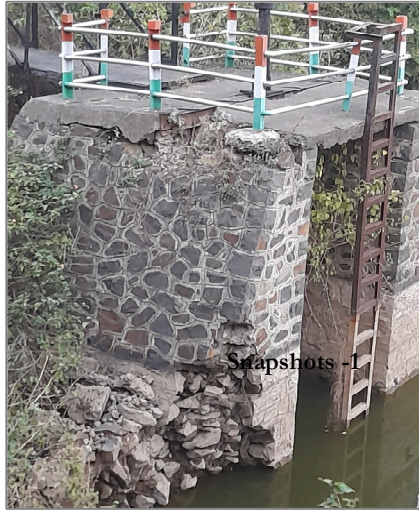
Snapshots -1
Kapra (Class-II)
Taluka – Ralegaon Dist – Yavatmal
Date of Inspection – 10/01/2022
L/S Wall of Outlet well collapsed at foundation level .(A6)

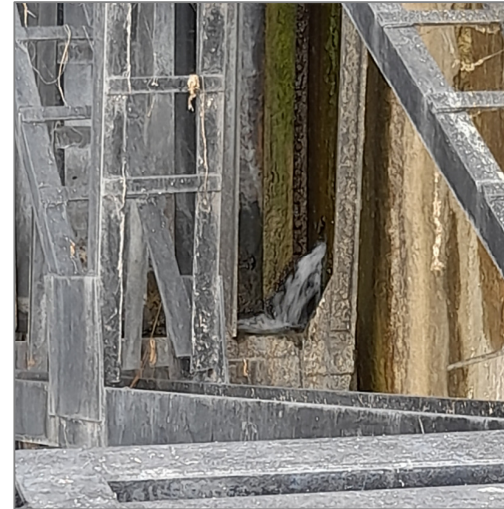
Snapshots -2

Lower Pus (Class-I)
Taluka – Buldana Dist – Buldana
Date of Inspection –12/01/2022
Heavy leakages were observed through pier no-8 (left side of gate no-8) just above crest level.
